DINEHART HOLT HOUSE

HISTORIC STRUCTURE REPORT

OCTOBER 31, 2017

DINEHART HOLT HOUSE HISTORIC STRUCTURES REPORT

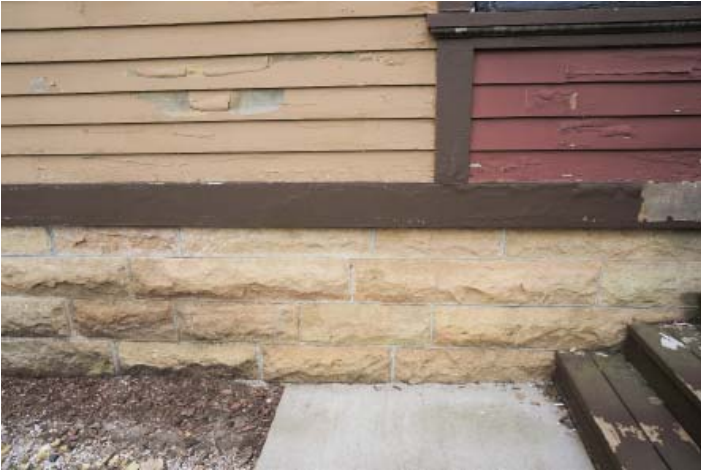
07 Typical area of limestone wall with loose mortar, prior re-pointing

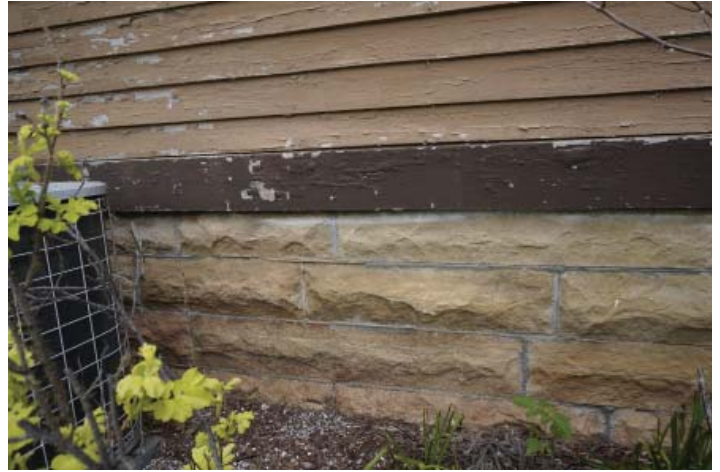
08 Typical area of limestone wall with loose mortar, prior re-pointing

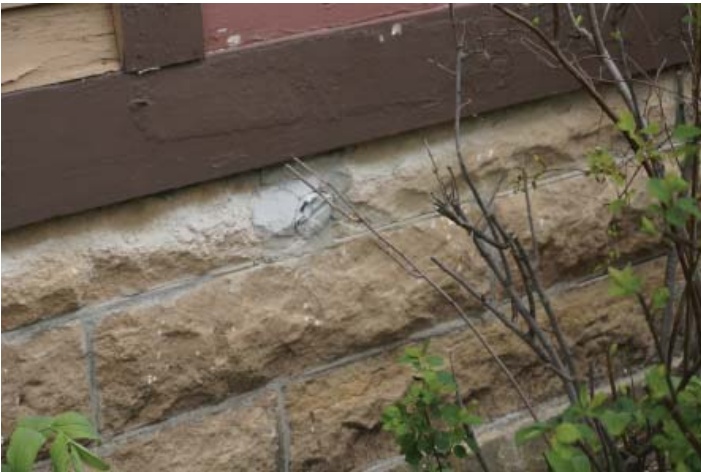
09 Hole patch at limestone wall

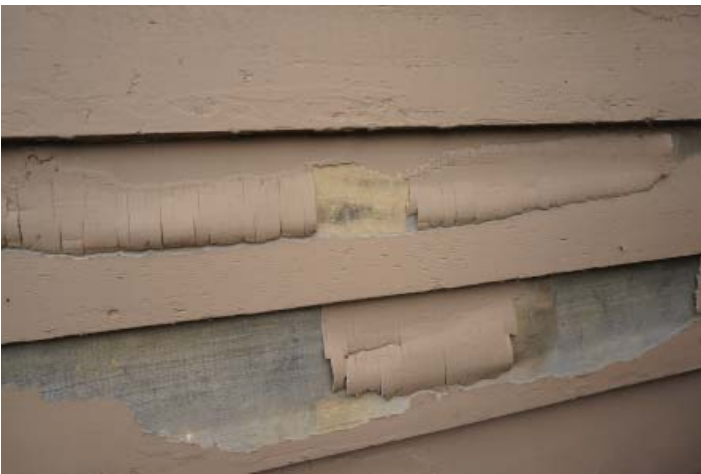
15 Siding with peeling paint

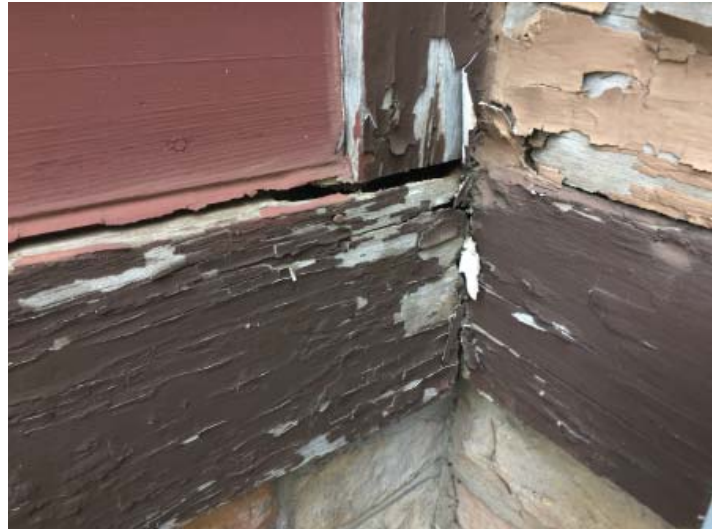
16 Siding & trim with peeling paint and areas of rot 03

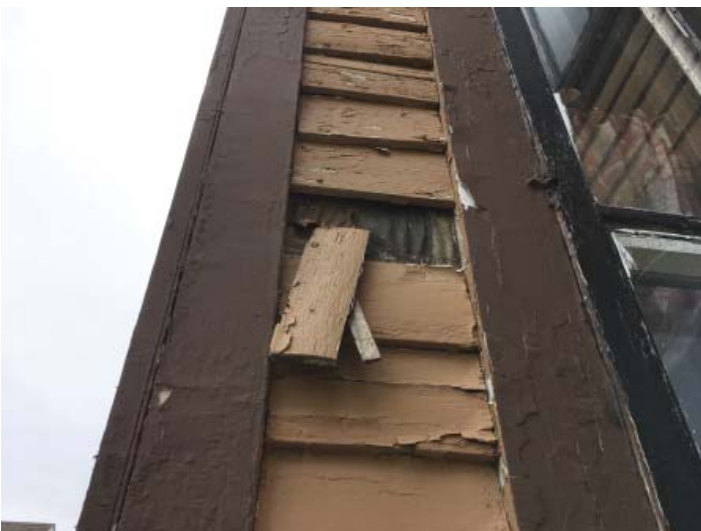
17 Loose siding

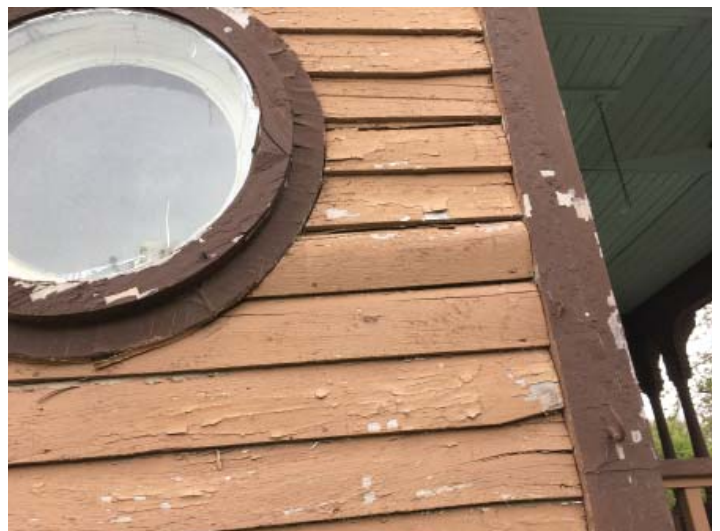
18 Split and cupped siding with peeling paint

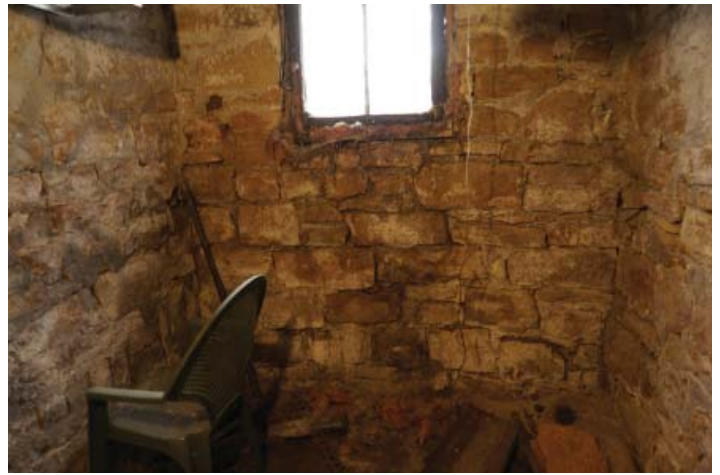
A08 Typical rubble stone basement wall - missing or loose mortar 2

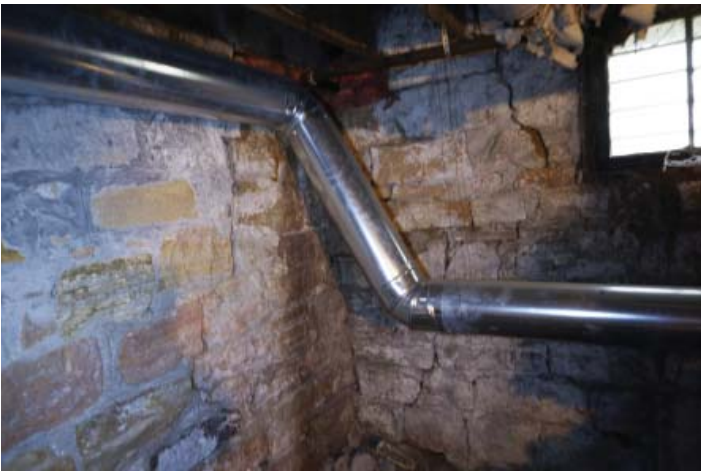
A09 Basement - SE corner wall crack, missing loose mortar

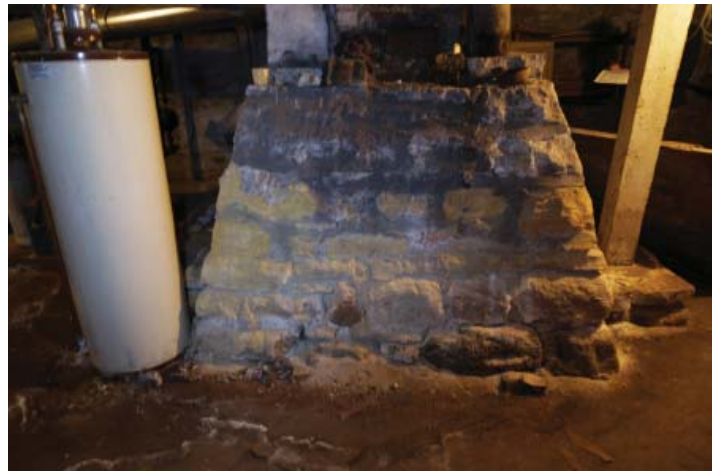
A10 Chimney foundation - note missing loose mortar

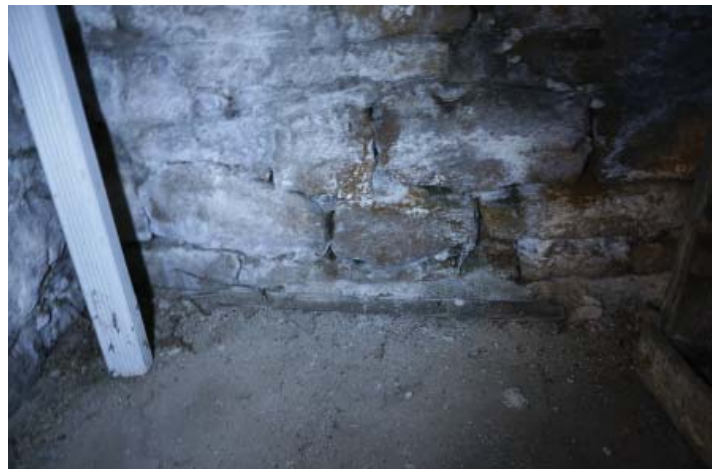
A12 Typical rubble stone basement wall - missing or loose mortar

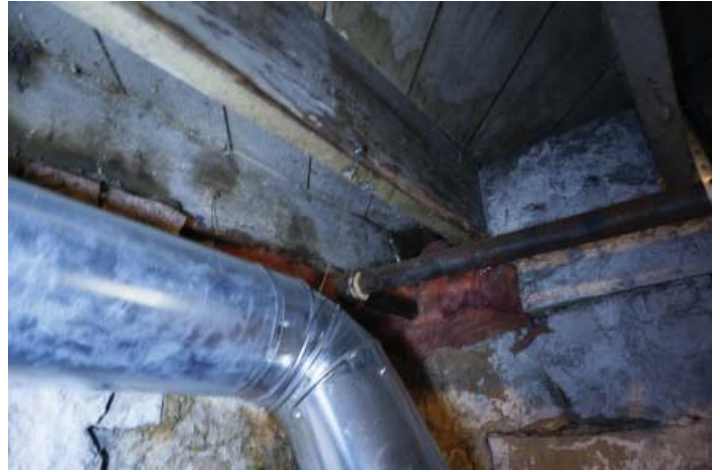
A14 Top of basement wall is missing at SE corner

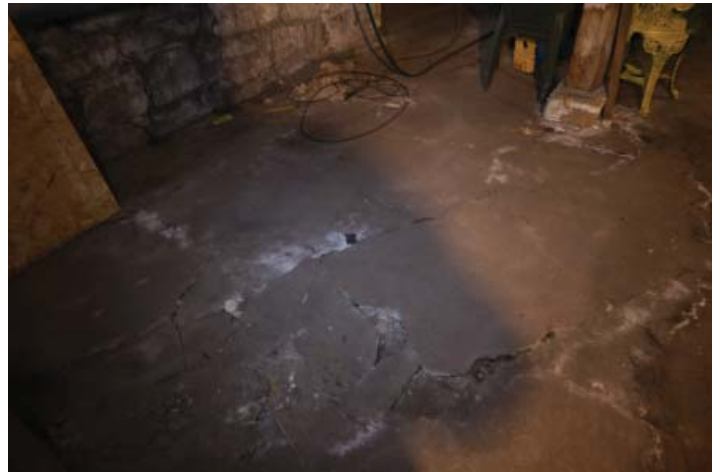
A16 Cracked, broken and heaving basement floor slab
