DINEHART HOLT HOUSE

HISTORIC STRUCTURE REPORT

OCTOBER 31, 2017

DINEHART HOLT HOUSE HISTORIC STRUCTURES REPORT

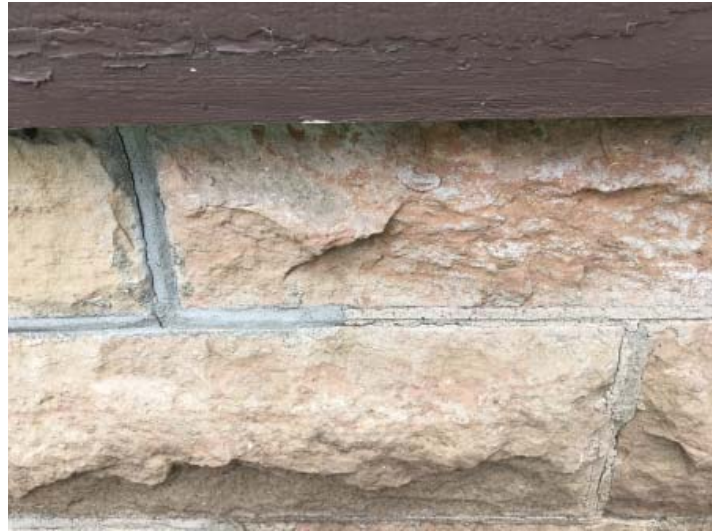
10 Closeup of repointing at limestone

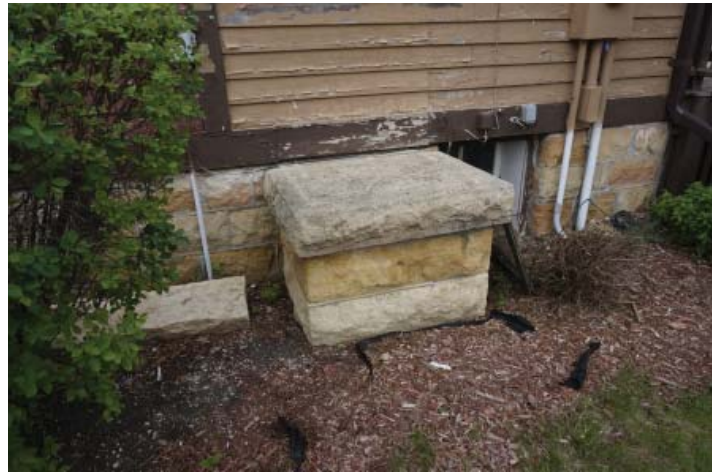
14 Abandoned chimney foundation

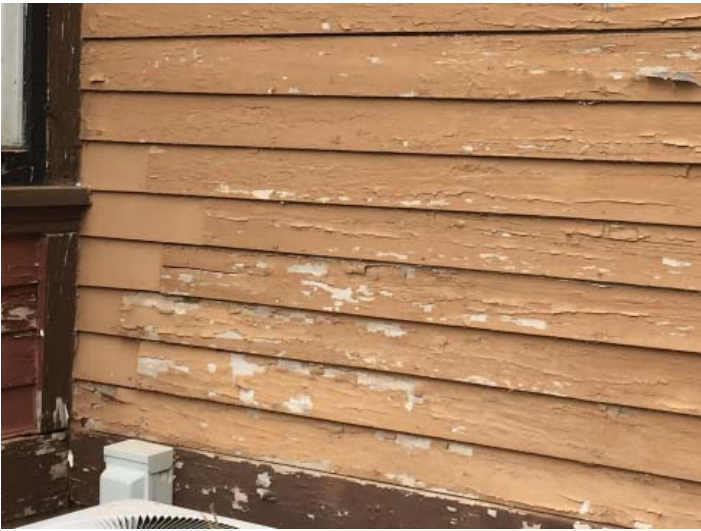
19 Area of replacement siding

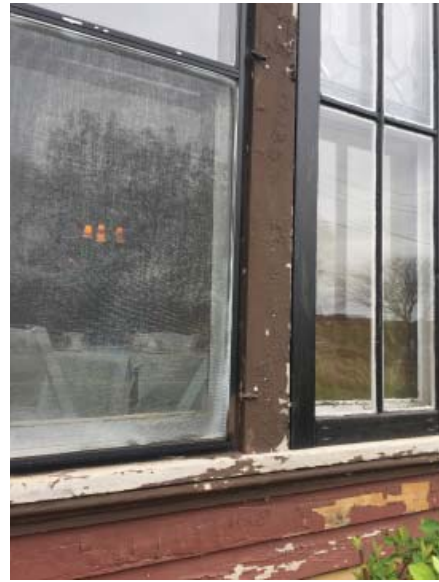
26 Peeling paint at window trim

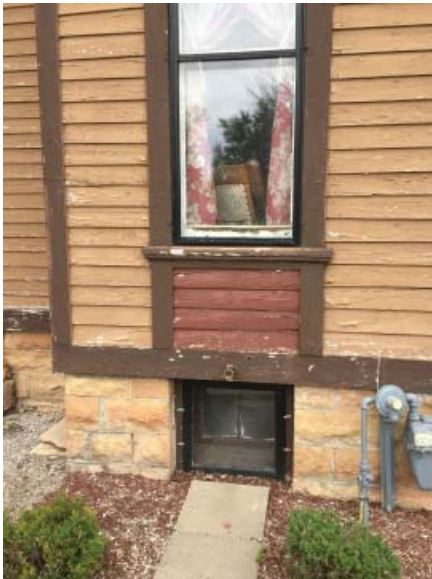
27 South windows, storm window, peeling paint

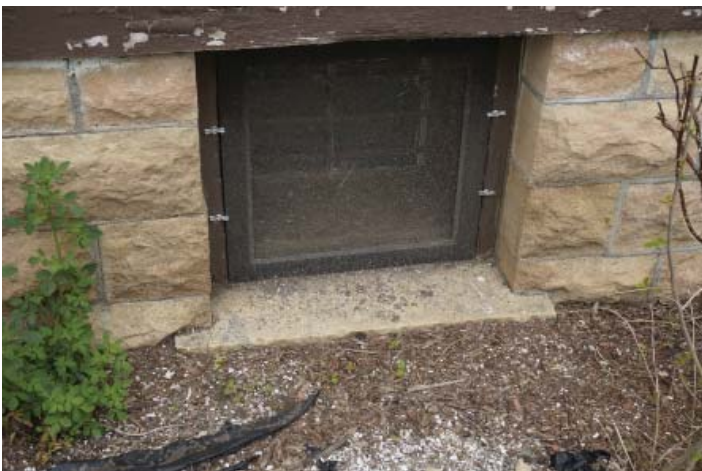
29 Basement window and sunken sill

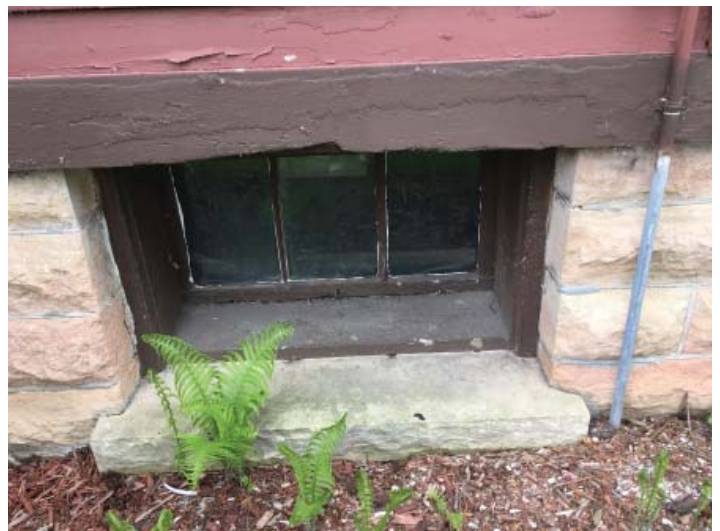
30 Basement window sill above grade

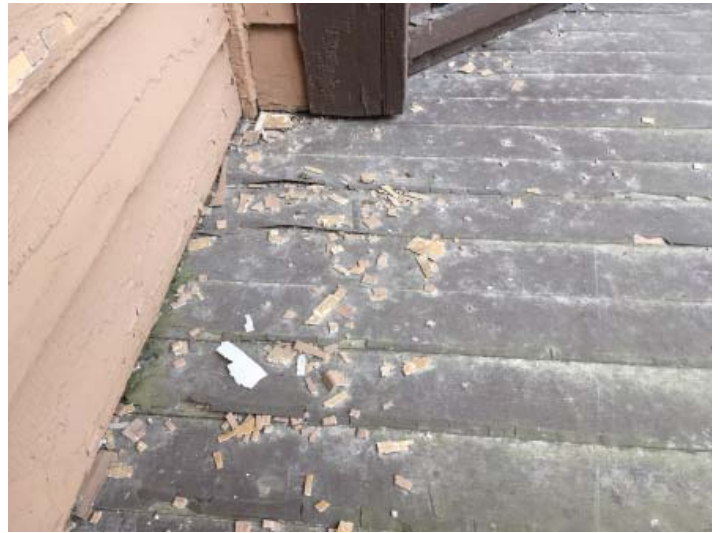
44 North porch flooring, chipped paint

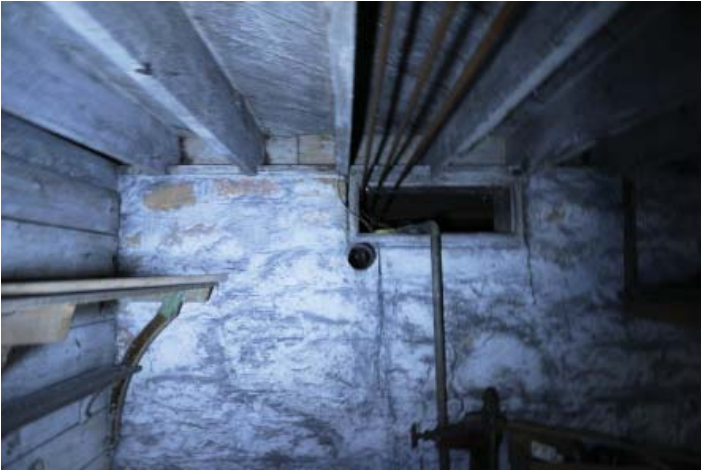
A13 typical floor joists bearing at 2x8 plate

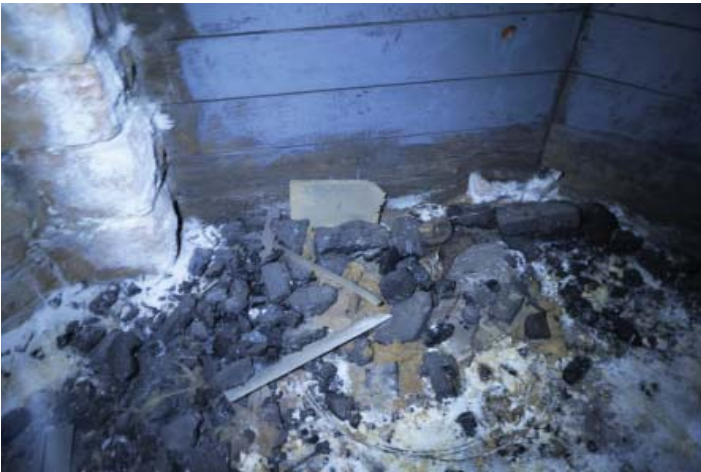
A15 coal storage area with dirt floor

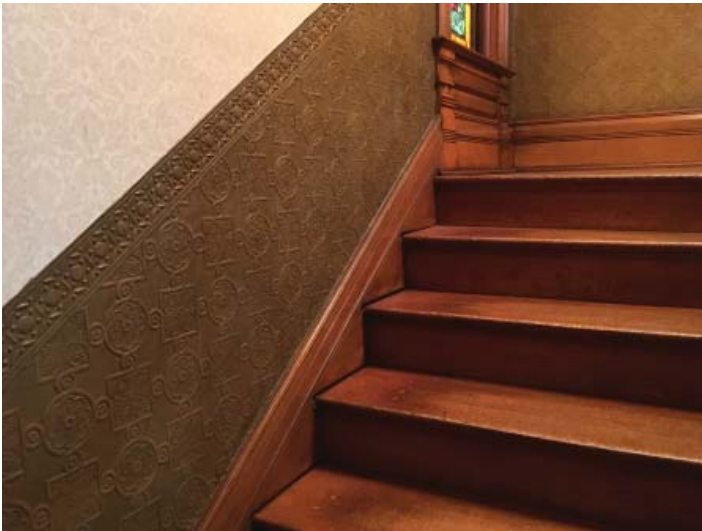
C03 Front Hall & Stair - Stair pulling away from wall

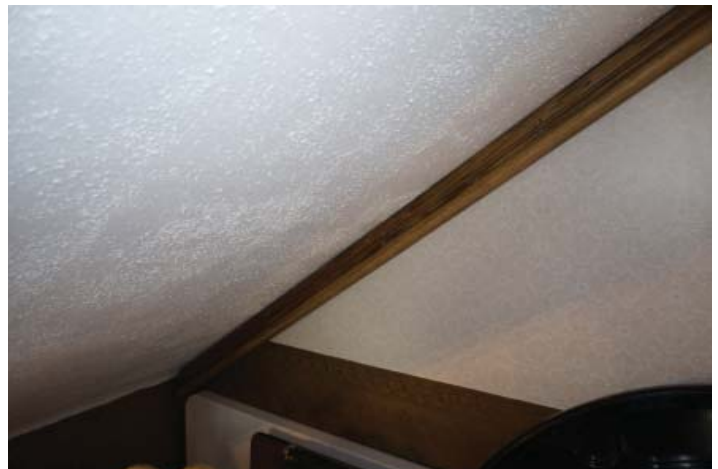
C06 Front Hall & Stair - Handrail installed under stair

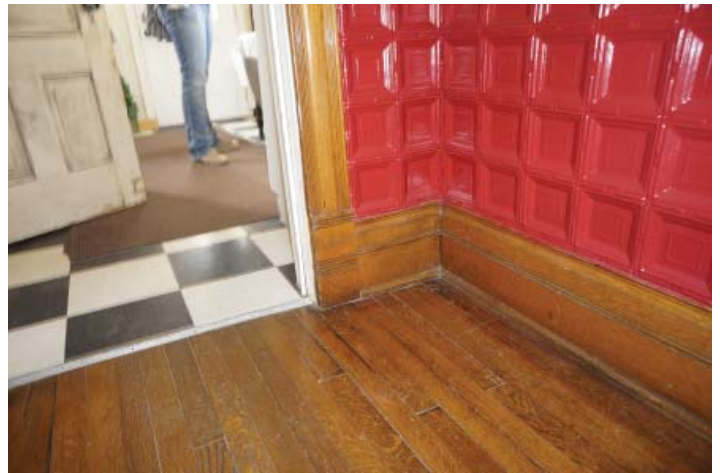
H06 Dining Room - Floor slopes to rear of building

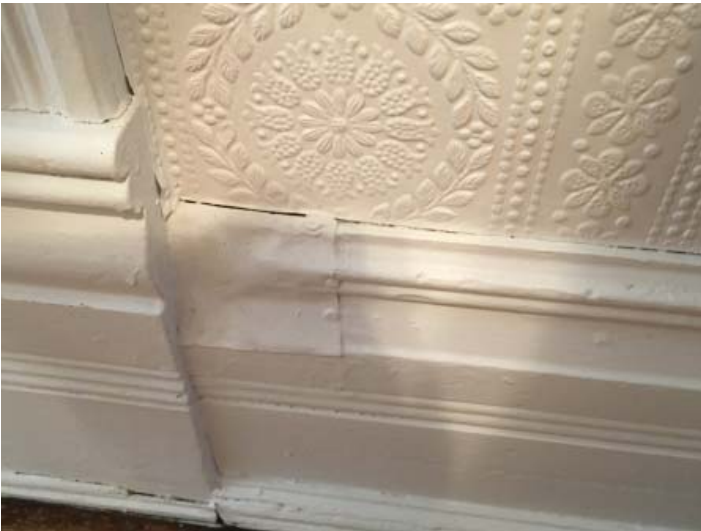
R07 Bedroom 3 Embossed wallpaper & wood trim with patch
